FULL RESERVE STUDY

Scofield Phase VIII Residential Owners Association, Inc.

Austin, Texas May 16, 2017

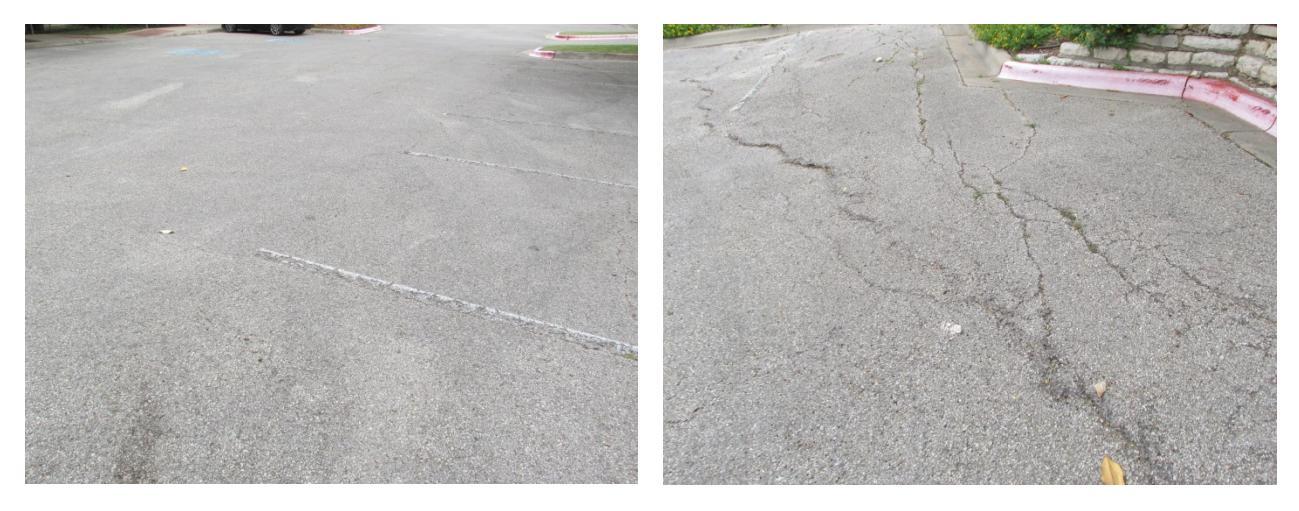
Condition: Good overall with cracks evident

Asphalt pavement parking area

Cracks at the parking area

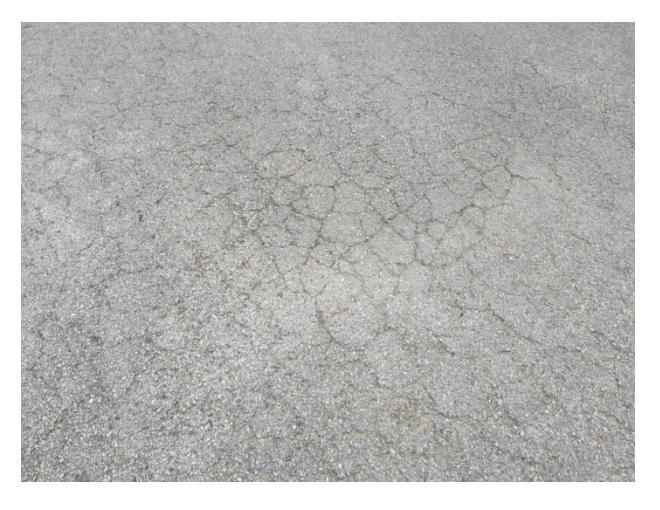
Alligator cracks at the parking area

The manner of repaving is either a mill and overlay or total replacement. A mill and overlay is a method of repaving where cracked, worn and failed pavement is mechanically removed or milled until sound pavement is found. A new layer of asphalt is overlaid atop the remaining base course of pavement. Total replacement includes the removal of all existing asphalt down to the base course of aggregate and native soil followed by the application of two or more new lifts of asphalt. We recommend mill and overlayment on asphalt pavement that exhibits normal deterioration and wear. We recommend total replacement of asphalt pavement that exhibits severe deterioration, inadequate drainage, pavement that has been overlaid multiple times in the past or where the configuration makes overlayment not possible. Based on the apparent visual condition and configuration of the asphalt pavement, we recommend the mill and overlay method for initial repaving followed by the total replacement method for subsequent repaving at Scofield Phase VIII.

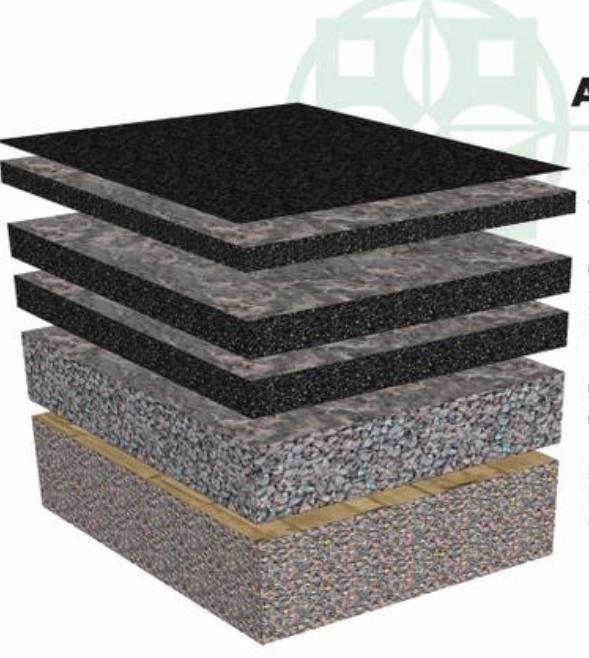
ASPHALT DIAGRAM

Component Detail Notes: The initial installation of asphalt uses at least two lifts, or two separate applications of asphalt, over the base course. The first lift is the binder course. The second lift is the wearing course. The wearing course comprises a finer aggregate for a smoother more watertight finish. The following diagram depicts these components:

Sealcoat or Wearing Surface Asphalt Overlay Not to Exceed 1.5 inch Thickness per Lift or Layer

Original Pavement Inspected and milled until sound pavement is found, usually comprised of two layers

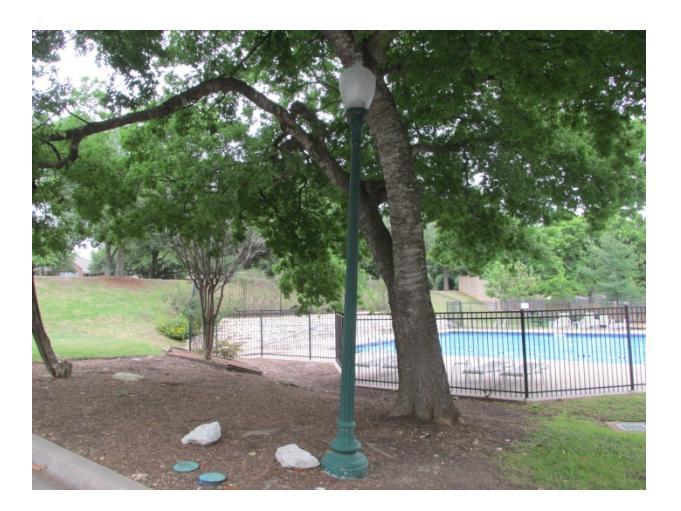
Condition: Good overall

Light pole and fixture

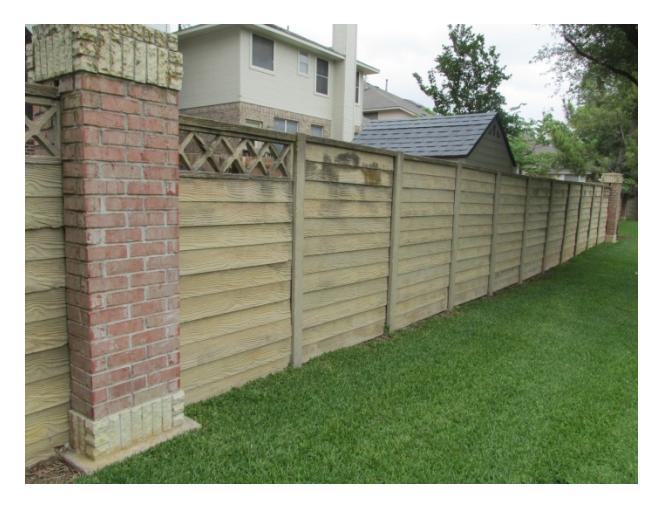
Condition: Good with isolated leaning sections and cracks evident

Panelized concrete perimeter walls

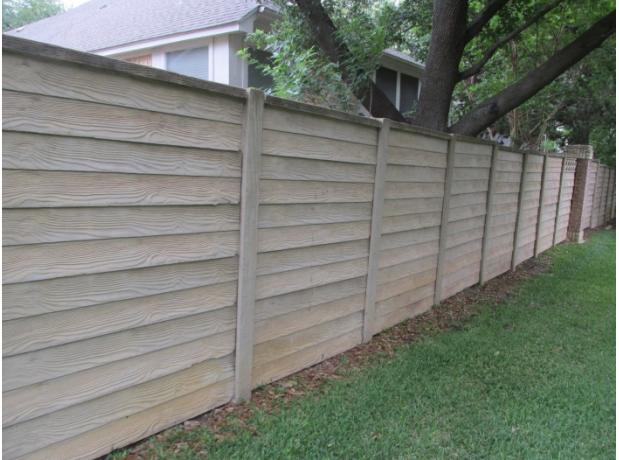
Panelized concrete in good condition

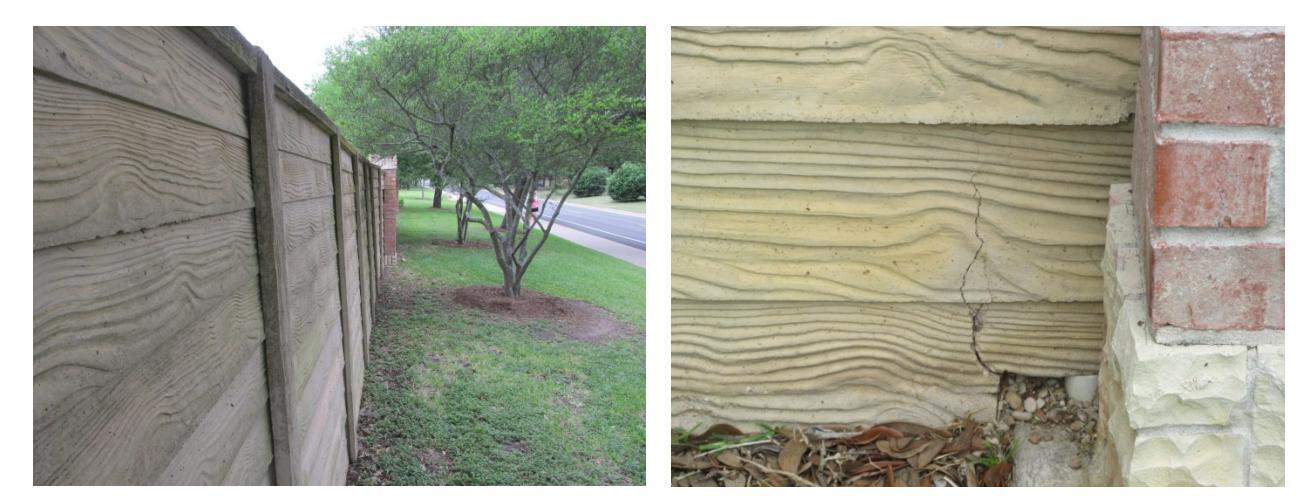
Isolated leaning section

Isolated crack

Priority/Criticality: Not recommended to defer

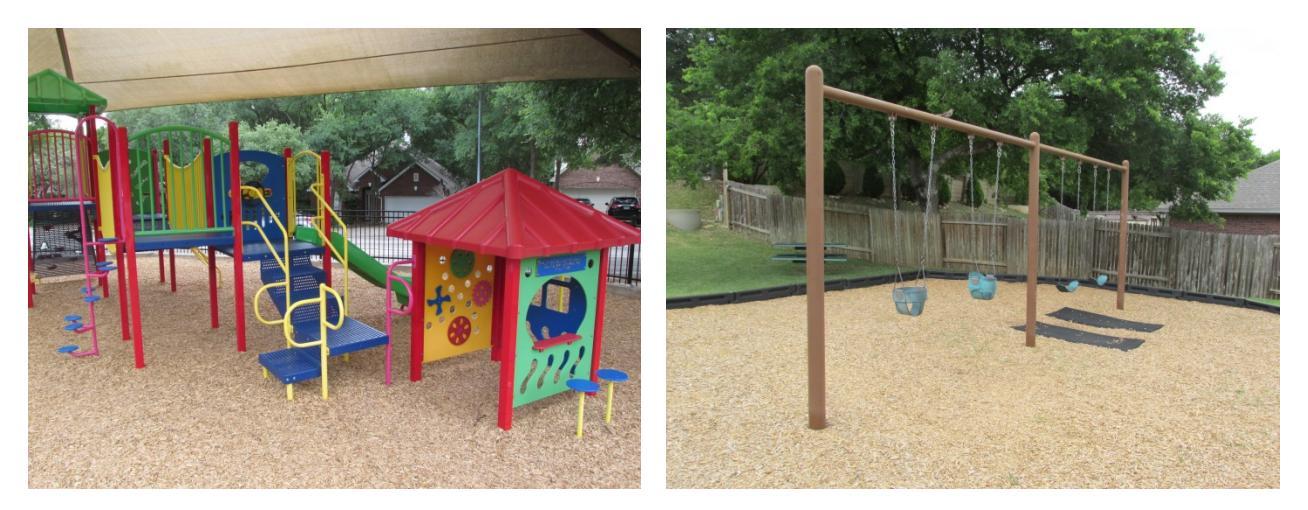
Condition: Good overall

Playset

Swing set

Component Detail Notes: Safety is the major purpose for maintaining playground equipment. We recommend an annual inspection of the playground equipment to identify and repair as normal maintenance loose connections and fasteners or damaged elements. We suggest the Association learn more about the specific requirements of playground equipment at PlaygroundSafety.org. We recommend the use of a specialist for the design or replacement of the playground equipment environment.

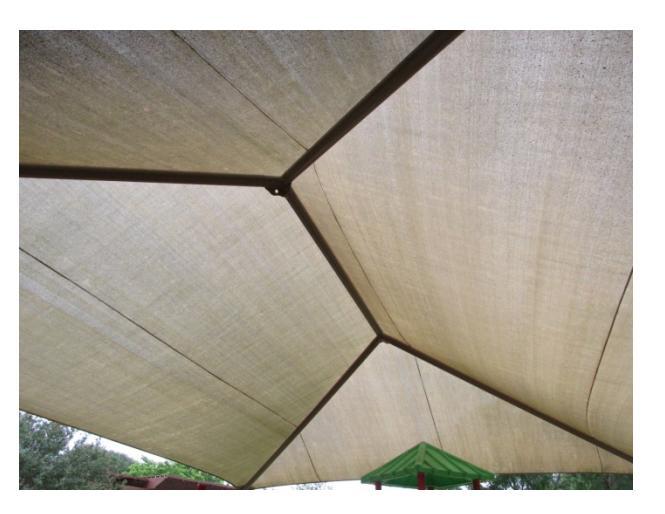
Condition: Good overall

Shade structure at the playset

Priority/Criticality: The fabric can be replaced at the Board's discretion. The structure should only be deferred upon the opinion of an independent professional or engineer.

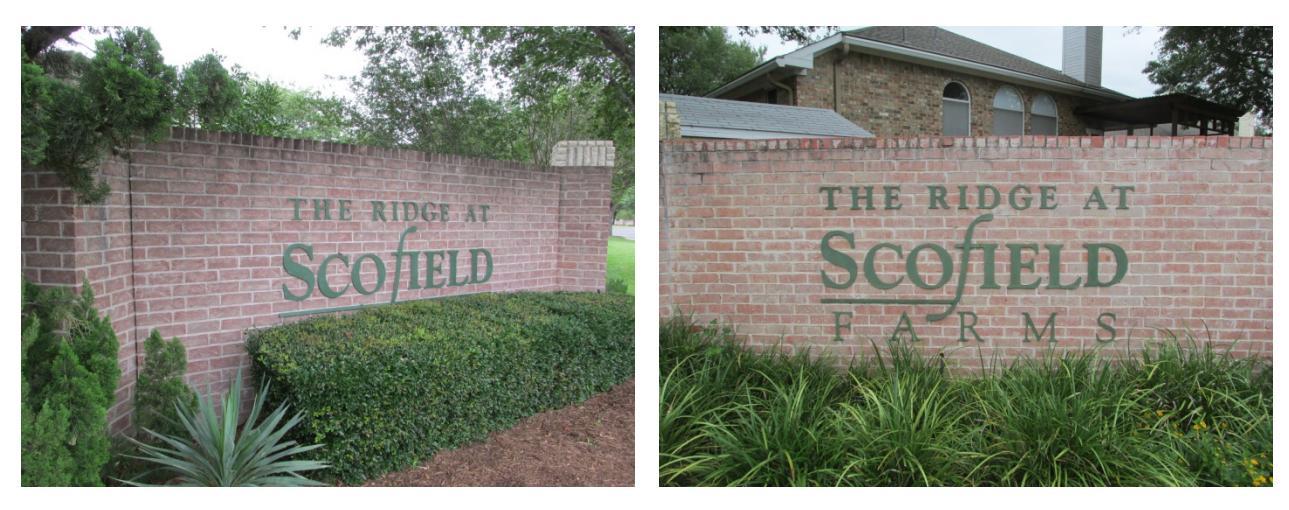
Condition: Good overall

Typical signage

Signage in good condition

Expenditure Detail Notes: Expenditure timing and costs are depicted in the **Reserve Expenditures** table in Section 3. Our cost for renovation includes repointing and repairs to the masonry and replacement of the remaining components listed above.

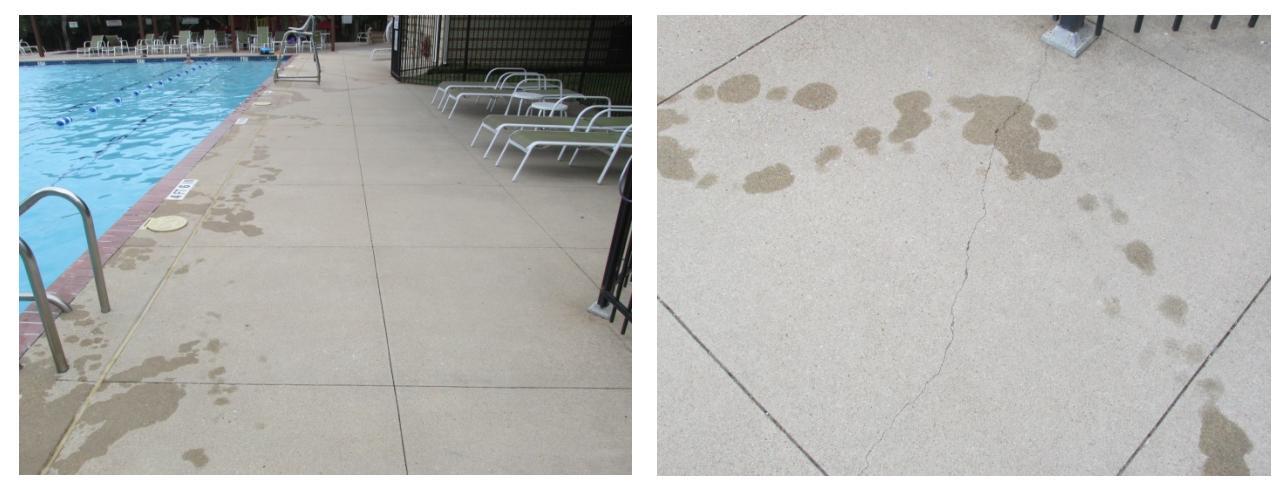
Condition: Good condition with isolated cracks evident

Concrete deck at the pool

Isolated crack

Component Detail Notes: We recommend the Association budget for the following:

- Selective cut out and replacements of up to ten percent (10%) of concrete
- Crack repairs as needed
- Mortar joint repairs
- Caulk replacement
- · Coating replacement at the pool house

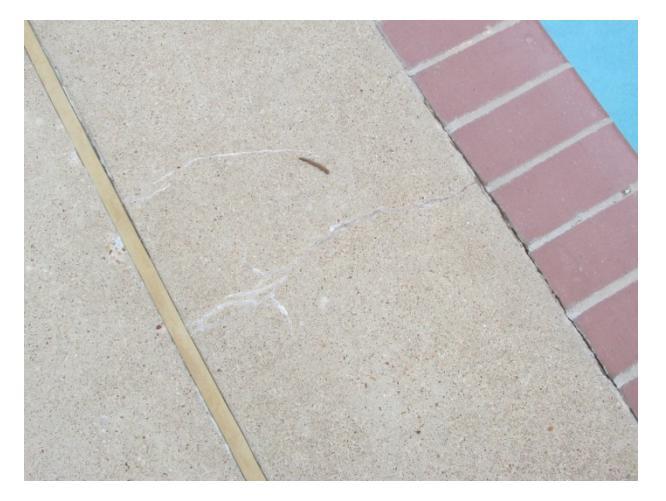
Isolated crack

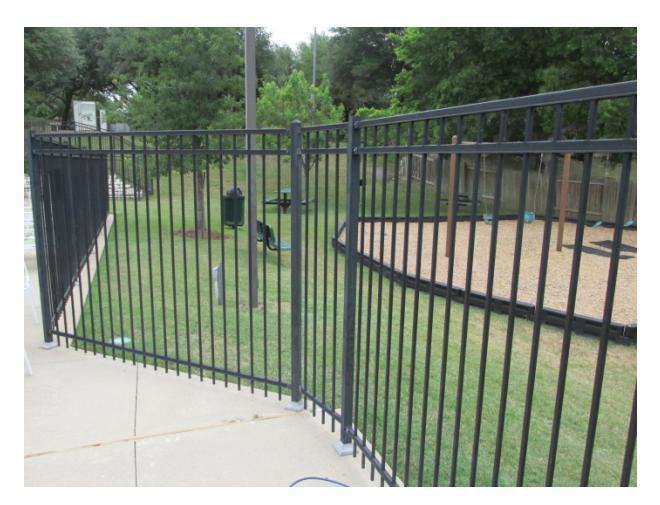
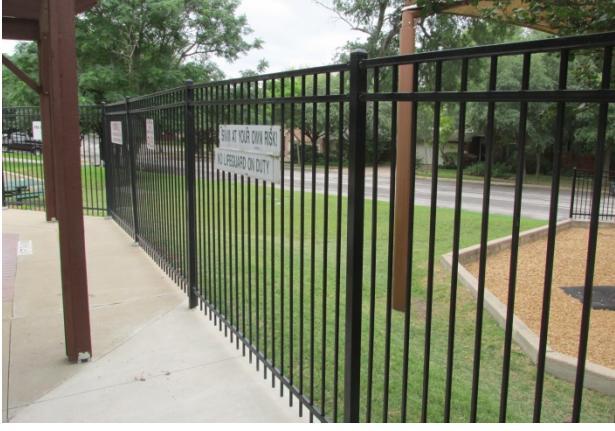
Condition: Good overall condition with no visible deterioration evident

Aluminum fence at the pool

Aluminum fence in good condition

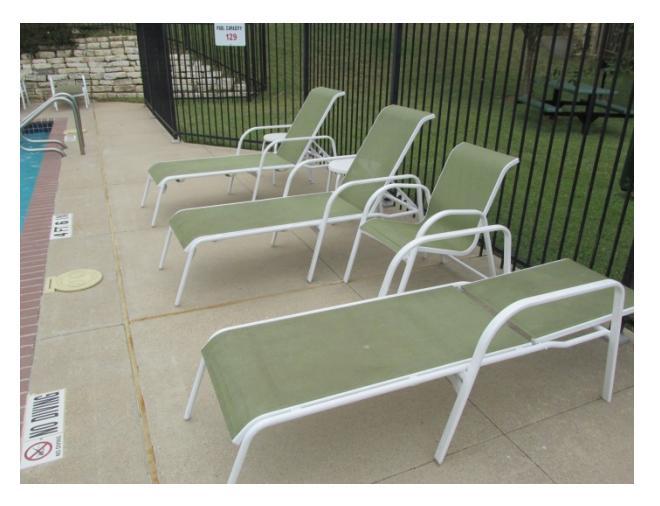
Condition: Good overall

Pool furniture

Expenditure Detail Notes: Expenditure timing and costs are depicted in the **Reserve Expenditures** table in Section 3. We recommend interim re-strapping, refinishing, cushion replacements, reupholstering and other repairs to the furniture as normal maintenance to maximize its useful life.

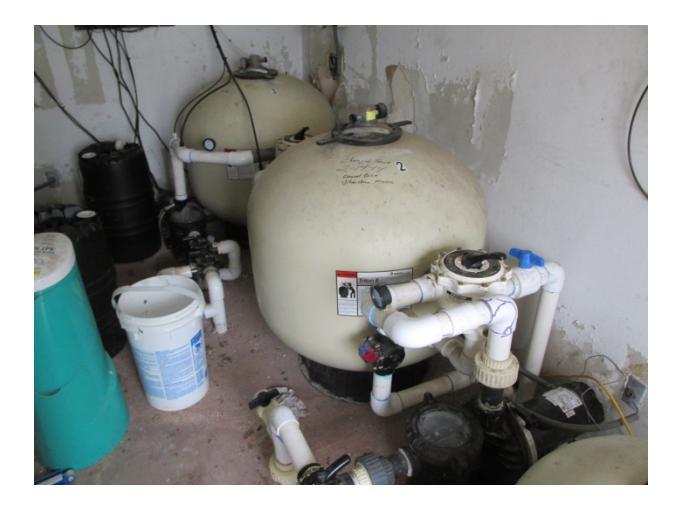
Condition: Reported unsatisfactory. The Board reports that the pump system will be replaced before the end of the year.

Pool mechanical equipment

Expenditure Detail Notes: Expenditure timing and costs are depicted in the **Reserve Expenditures** table in Section 3. Failure of the pool mechanical equipment as a single event is unlikely. We consider interim replacement of motors and minor repairs as normal maintenance.

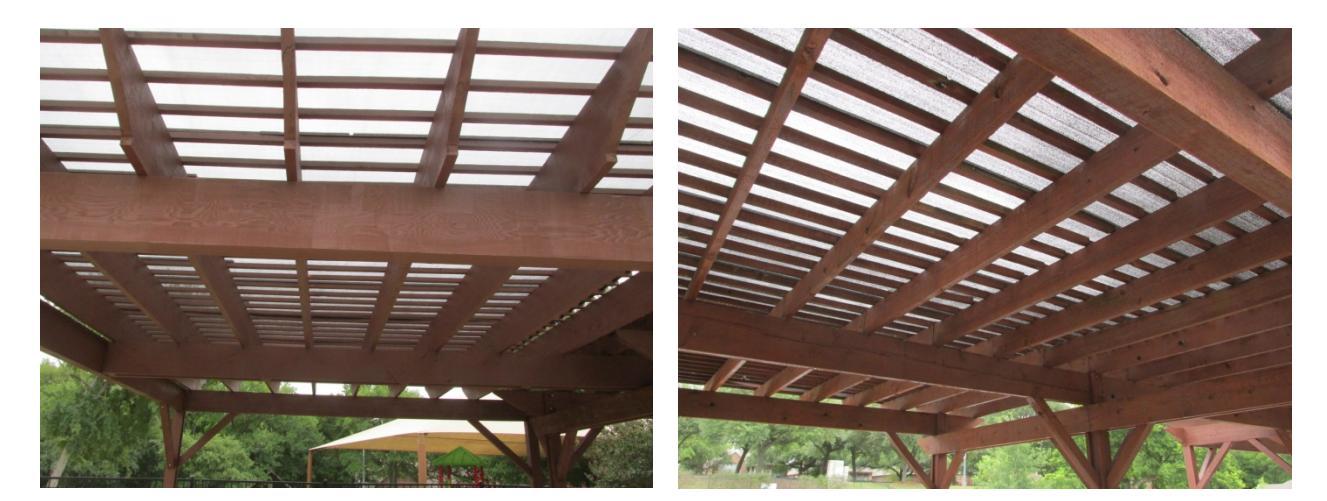
Condition: Good overall

New pergola

Section of old pergola

Expenditure Detail Notes: Expenditure timing and costs are depicted in the **Reserve Expenditures** table in Section 3. The Association should anticipate periodic partial replacements due to the non-uniform nature of wood deterioration. Along with these partial replacements, the Association should apply periodic paint applications as needed and fund these activities through the operating budget.

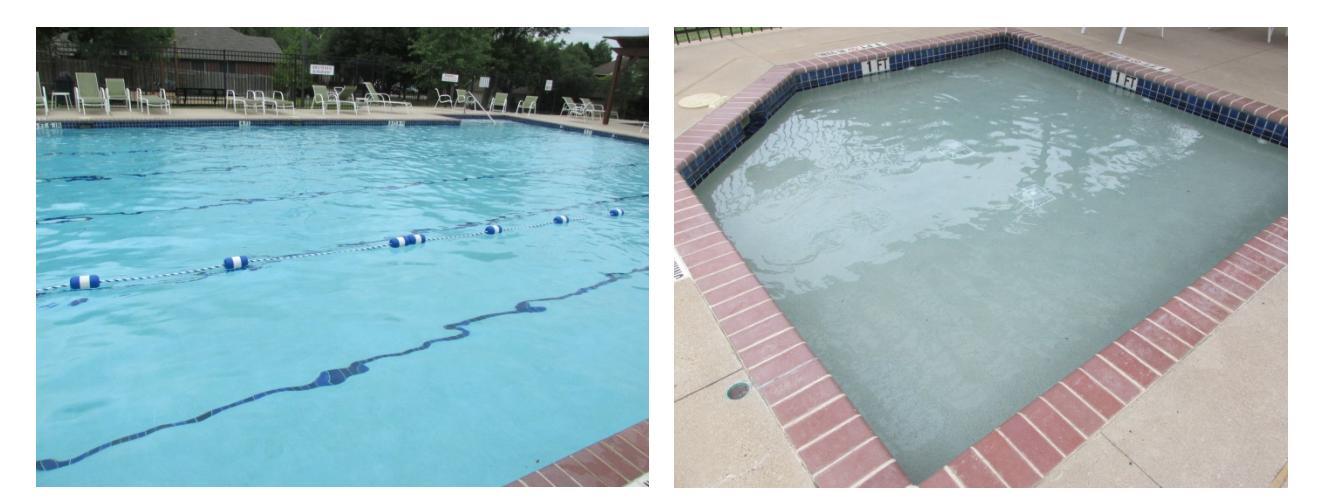
Main pool overview

Wading pool overview

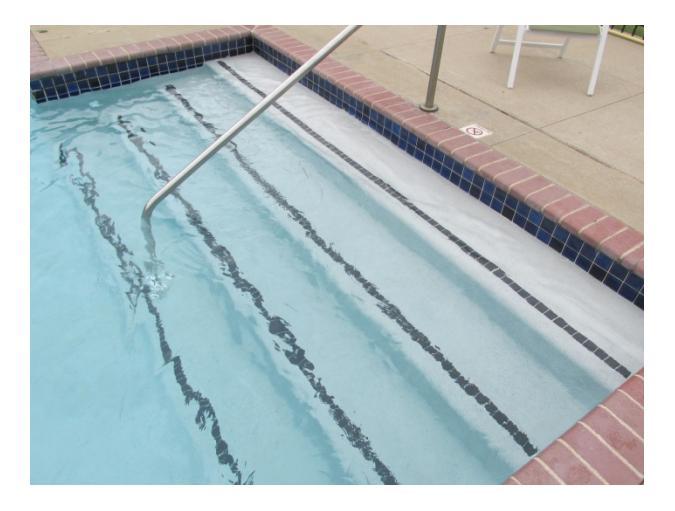
Plaster at steps in good condition

Component Detail Notes: Removal and replacement provides the opportunity to inspect the pool structures and to allow for partial repairs of the underlying concrete surfaces as needed. To maintain the integrity of the pool structures, we recommend the Association budget for the following

- Removal and replacement of the finishes
- Partial replacements of the scuppers and coping as needed
- Replacement of tiles as needed
- Replacement of joint sealants as needed
- Concrete structure repairs as needed

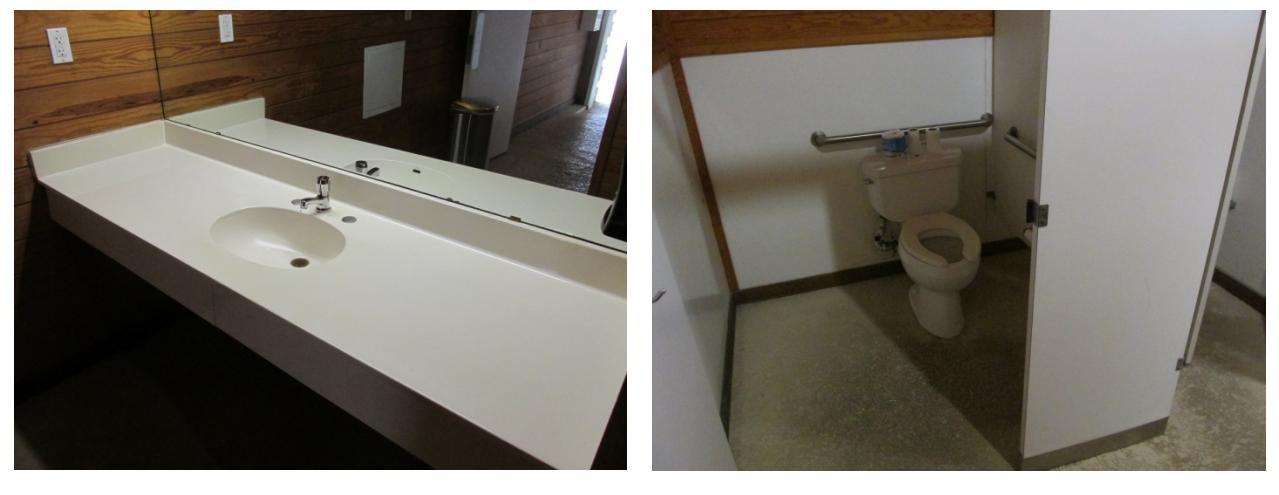
Condition: Good overall

Restroom sink

Restroom plumbing fixture and partition

Expenditure Detail Notes: Expenditure timing and costs are depicted in the **Reserve Expenditures** table in Section 3. Our renovation cost includes partial repairs to the concrete flooring and replacement of the remaining components listed above except for the plumbing fixtures and partitions.

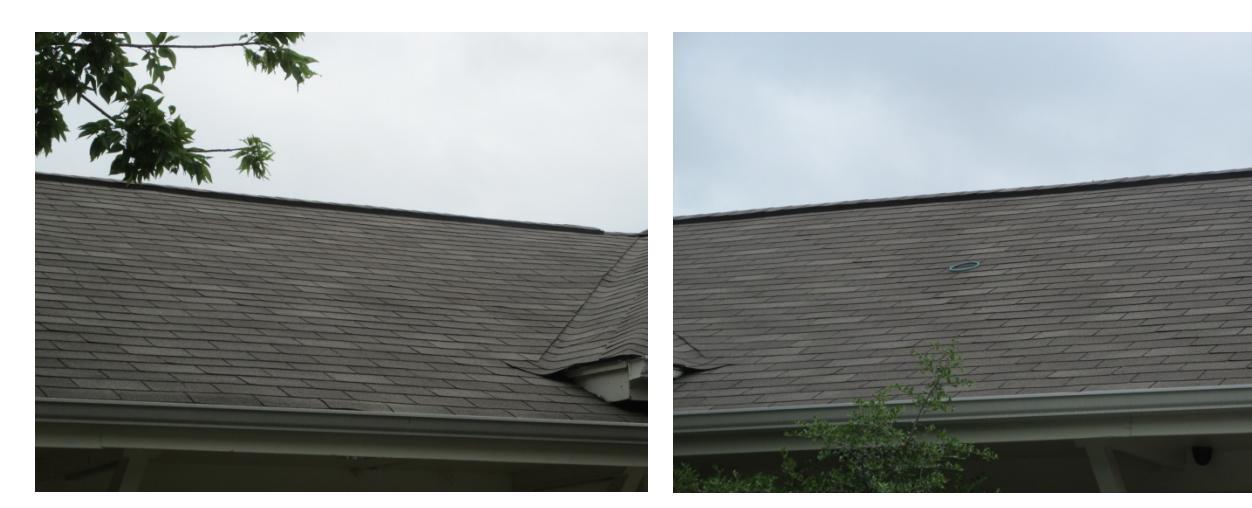
Condition: Good overall. The Board does not report a history of leaks.

Asphalt shingle roof at the pool house

Asphalt shingle roof in good condition

Contractors use one of two methods for replacement for sloped roofs, either an overlayment or a tear-off. Overlayment is the application of new shingles over an existing roof. However, there are many disadvantages to overlayment including hidden defects of the underlying roof system, absorption of more heat resulting in accelerated deterioration of the new and old shingles, and an uneven visual appearance. Therefore, we recommend only the tear-off method of replacement. The tear-off method of replacement includes removal of the existing shingles, flashings if required and underlayments.

Expenditure Detail Notes: Expenditure timing and costs are depicted in the **Reserve Expenditures** table in Section 3. We base our cost on replacement with standard laminate Class A 240-260-pounds per square shingles.
